## Mapping The Spatial Extent Of Ground Dust/Debris From The Collapse Of The World Trade Center Buildings

New York, New York

Appendix A, Figures  
July, 2004

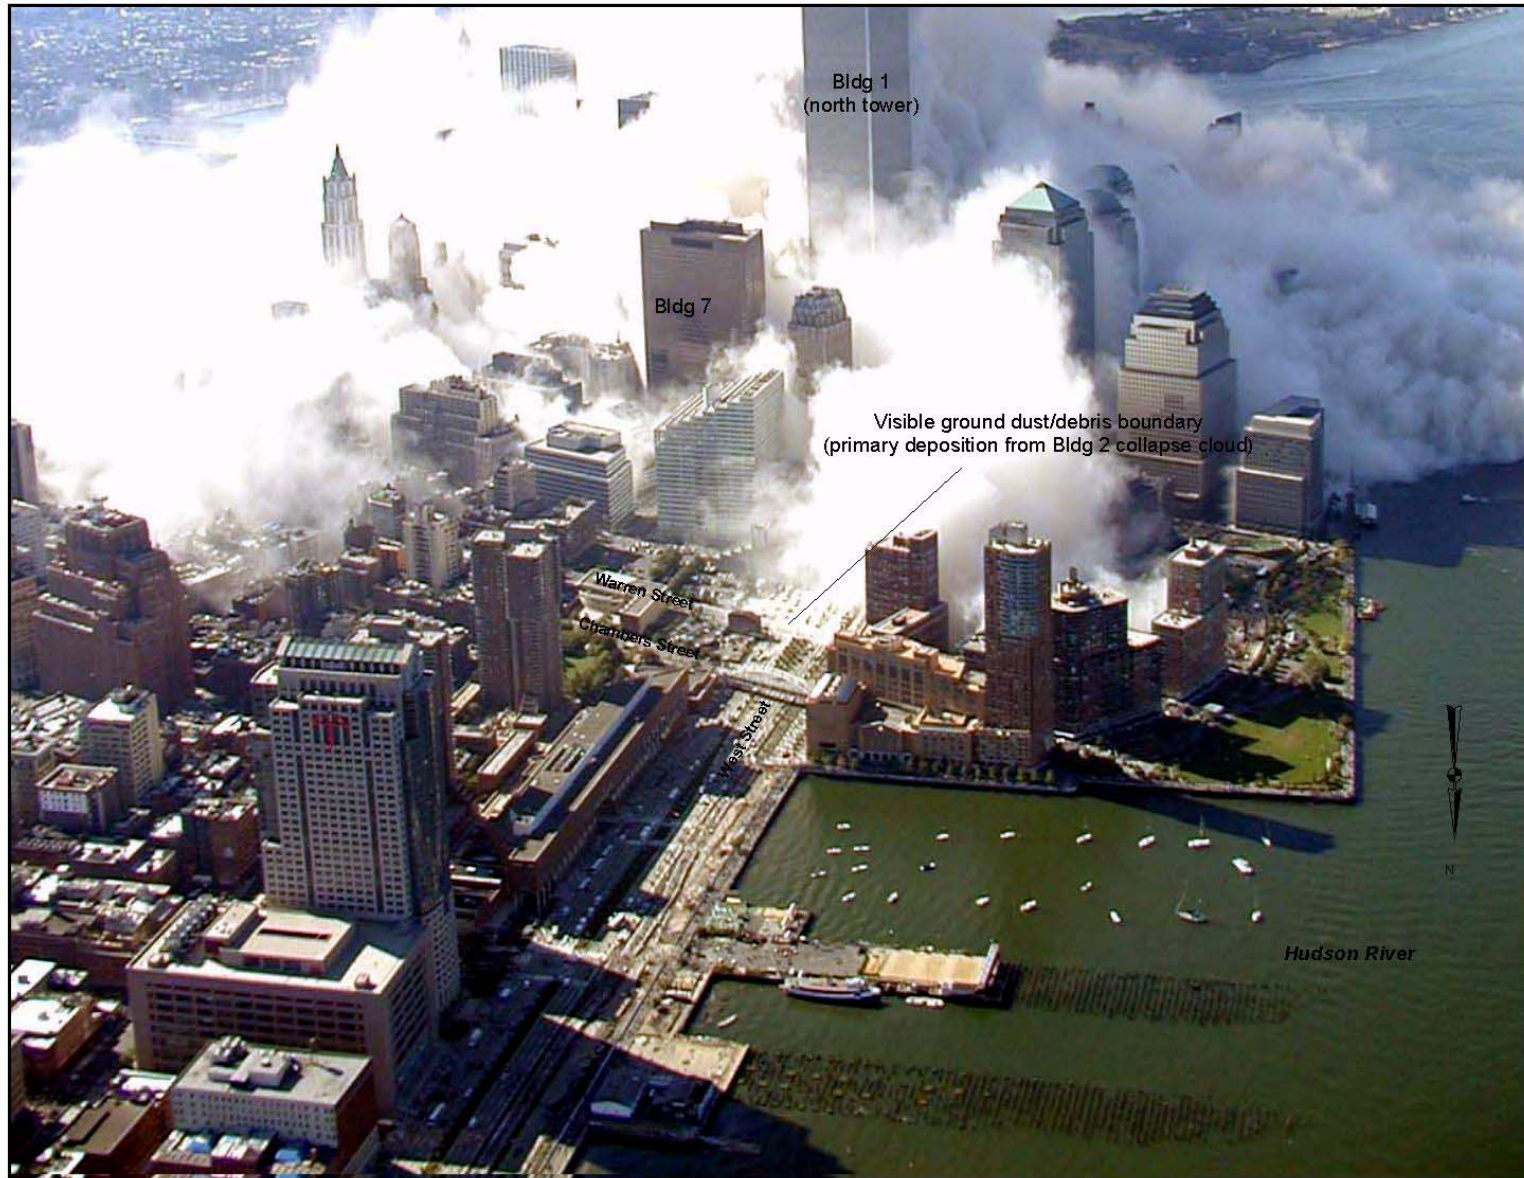
Figure 2A. September 11, 2001. Source: NYPD image 4. Time is approximately between 10:00 am - 10:30 am. A view of lower Manhattan looking south along West Street. The collapse cloud from WTC building 2 is evident while building 1 and building 7 remain standing. A visible demarcation of dust/debris is present at the intersection of West and Warren Streets.

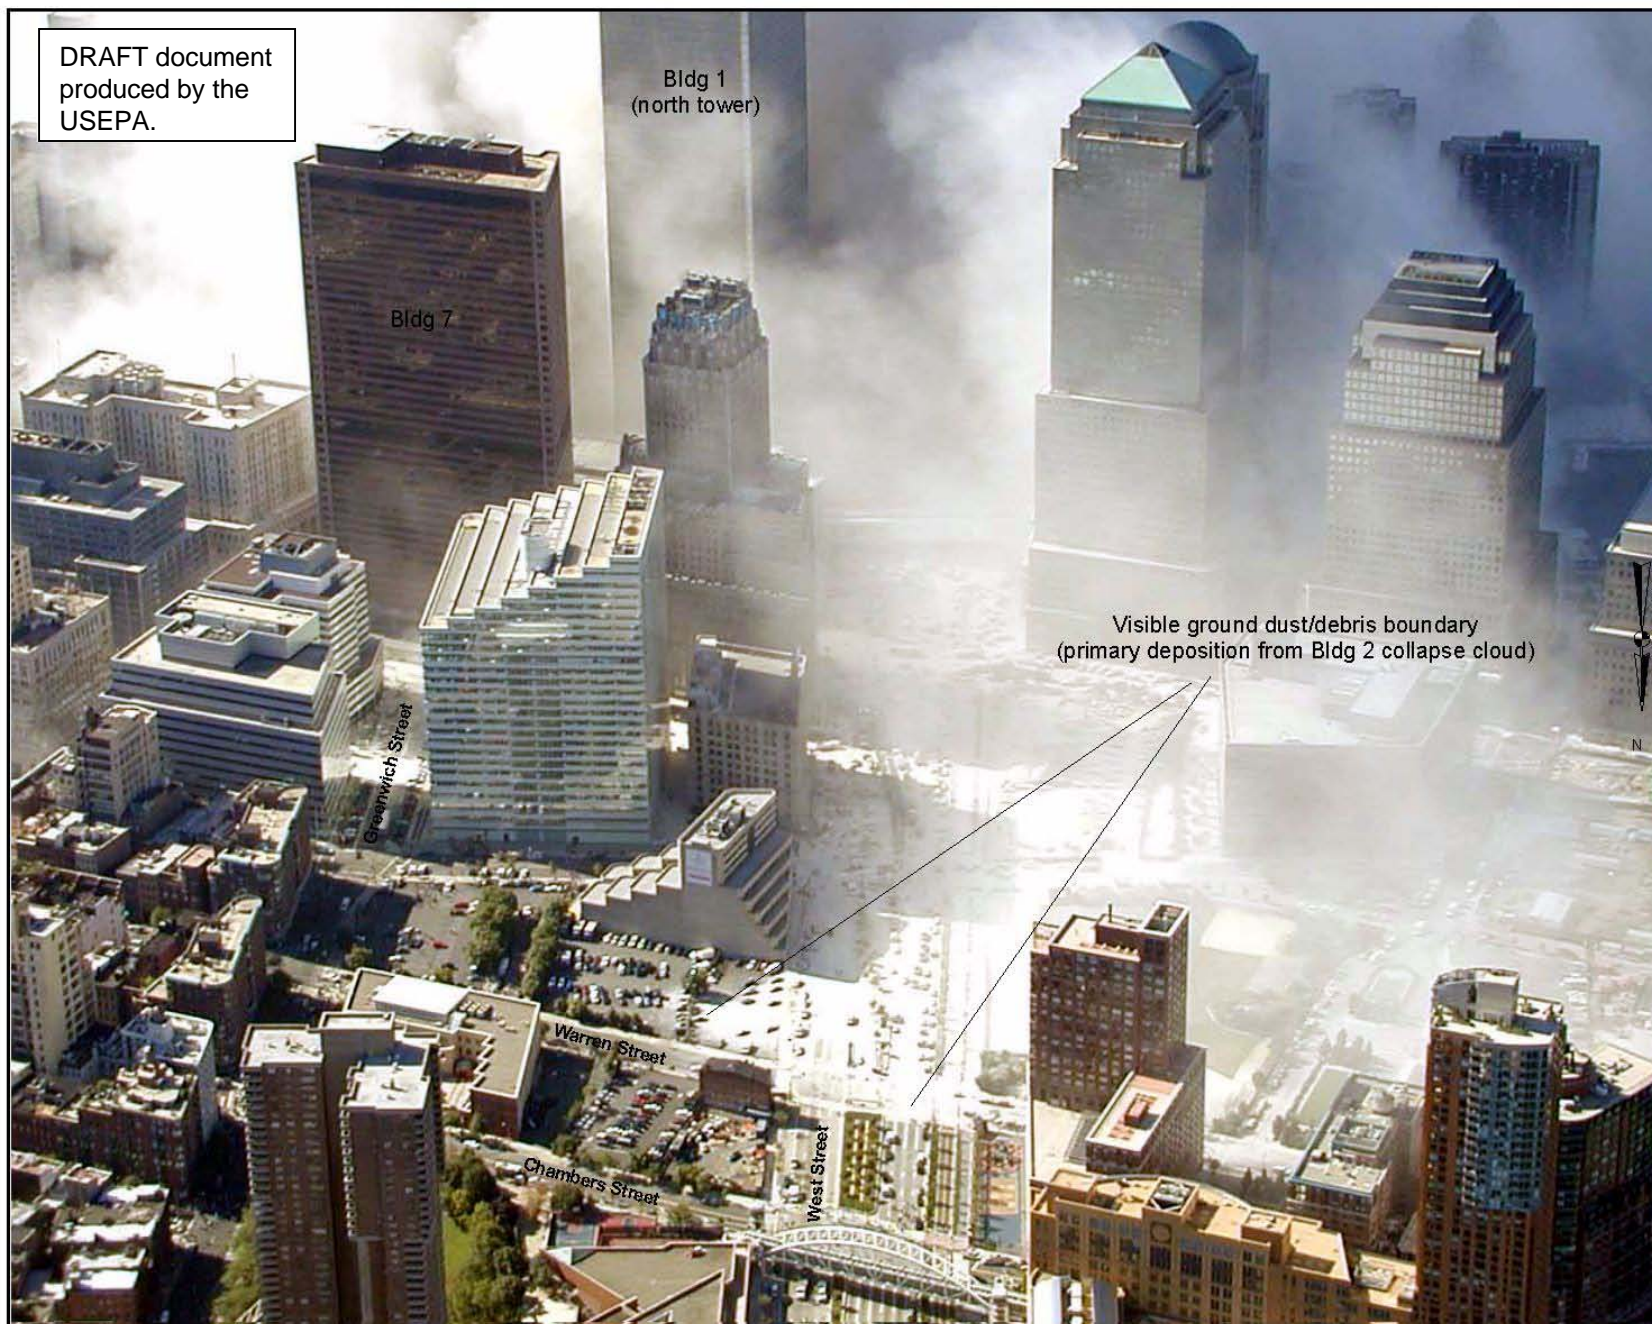
Figure 2B. September 11, 2001. Source: NYPD image 17. Time is approximately between 10:00 am - 10:30 am. A view of lower Manhattan looking south along West Street towards "Ground Zero". The northern extent of the collapse cloud from WTC building 2 has begun to recede. WTC Buildings 1 and 7 remain standing.

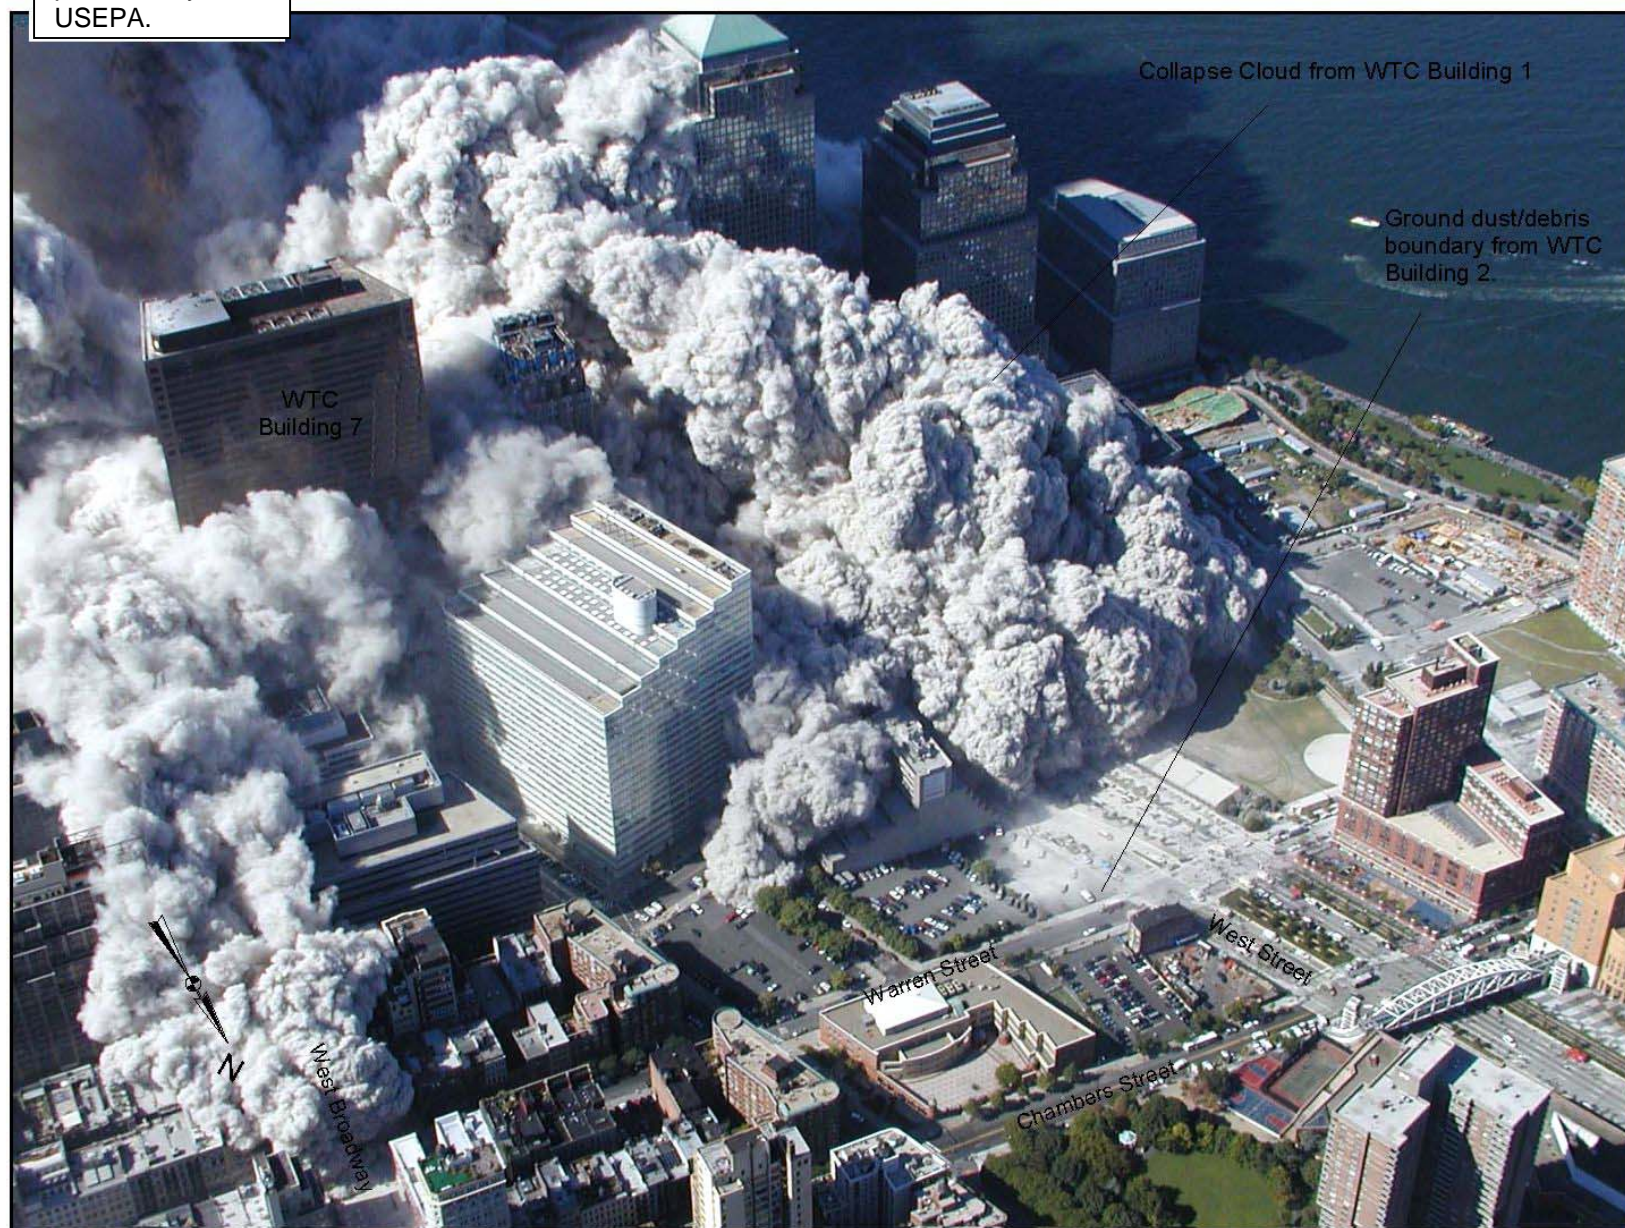
Figure 2C. September 11, 2001. Time is approximately 10:30 am. Source: NYPD image 32. The WTC building 1 collapse cloud is evident funneling north along West Street and West Broadway. WTC building 7 remains standing. The ground dust/debris boundary produced by WTC building 2 remains visible.

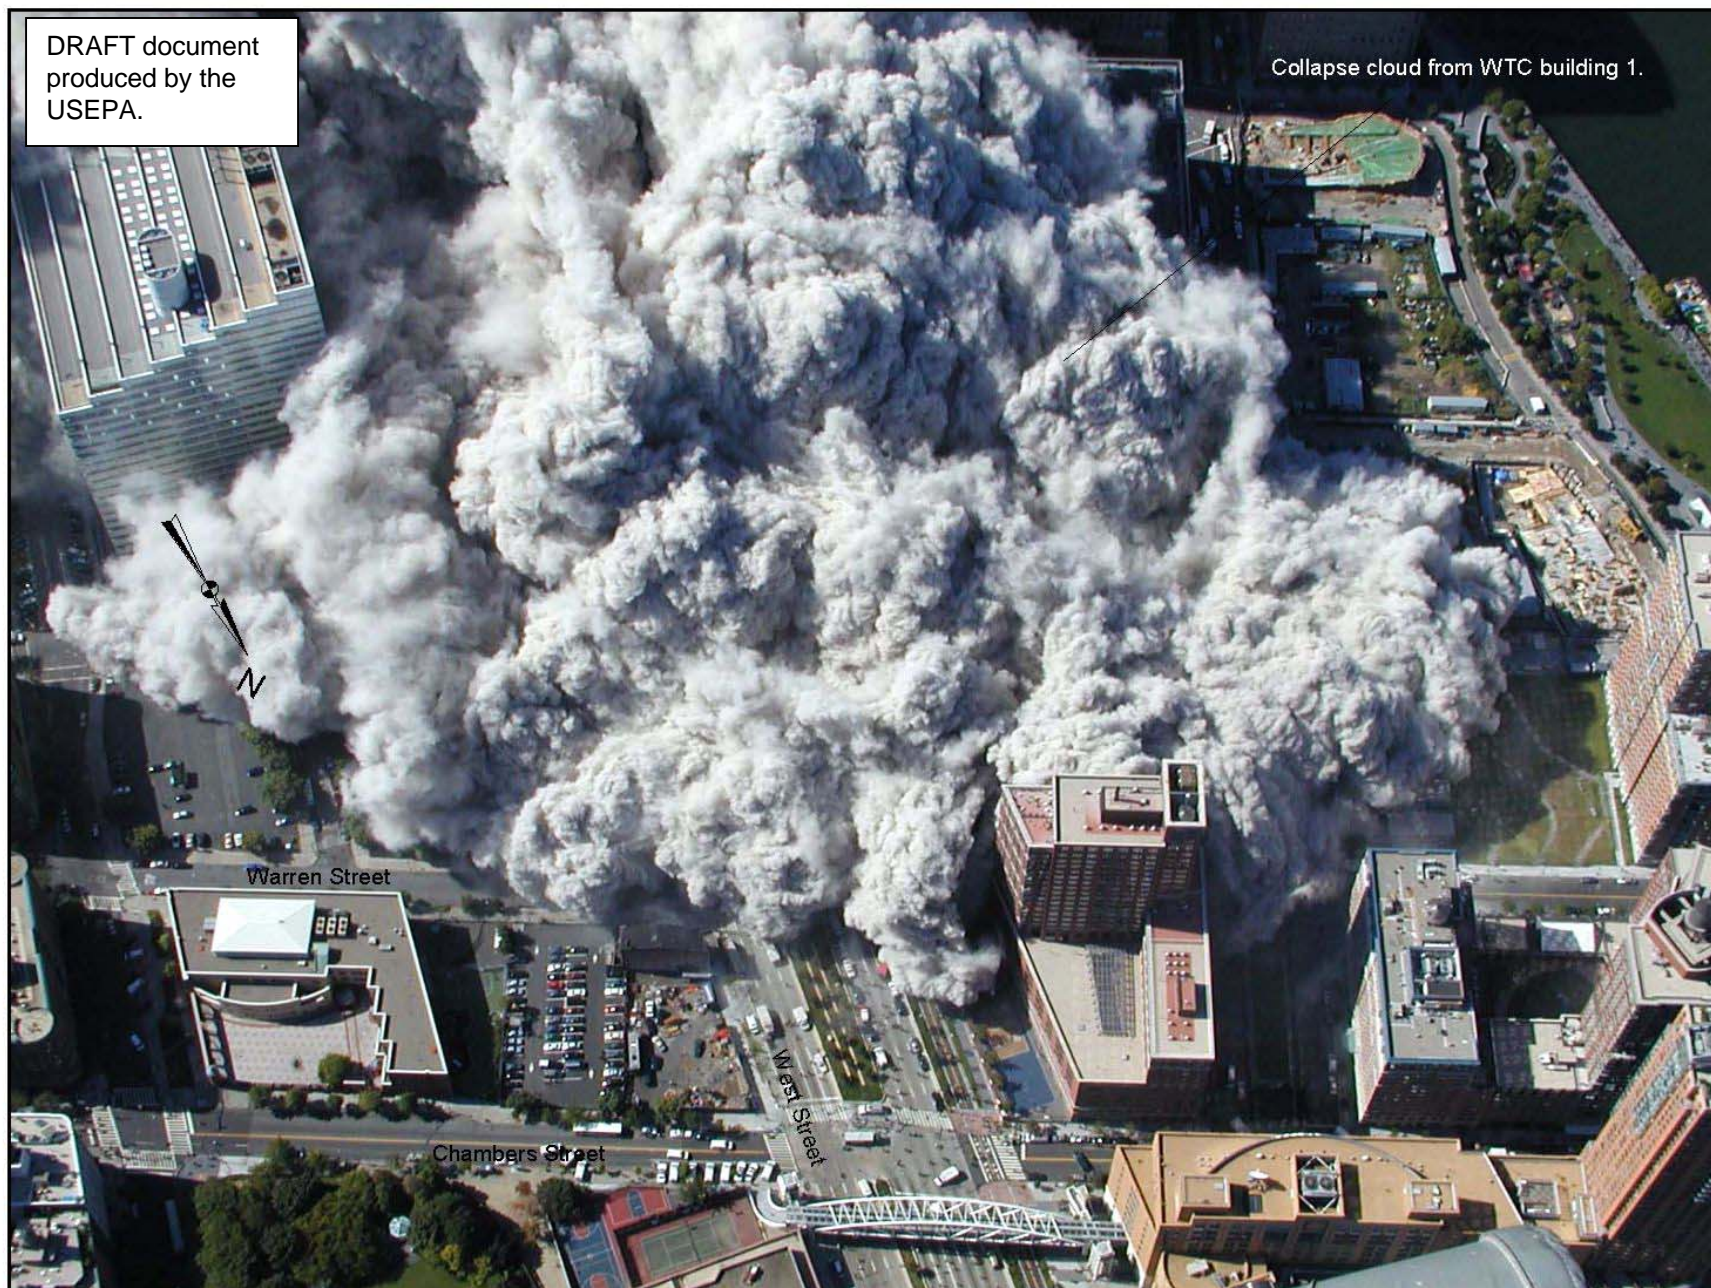
Figure 2D. September 11, 2001. Source: NYPD image 35. Time is approximately 10:30am. The WTC building 1 collapse cloud, funneling north along West Street, has enveloped the ground dust/debris boundary produced by the collapse of WTC building 2.

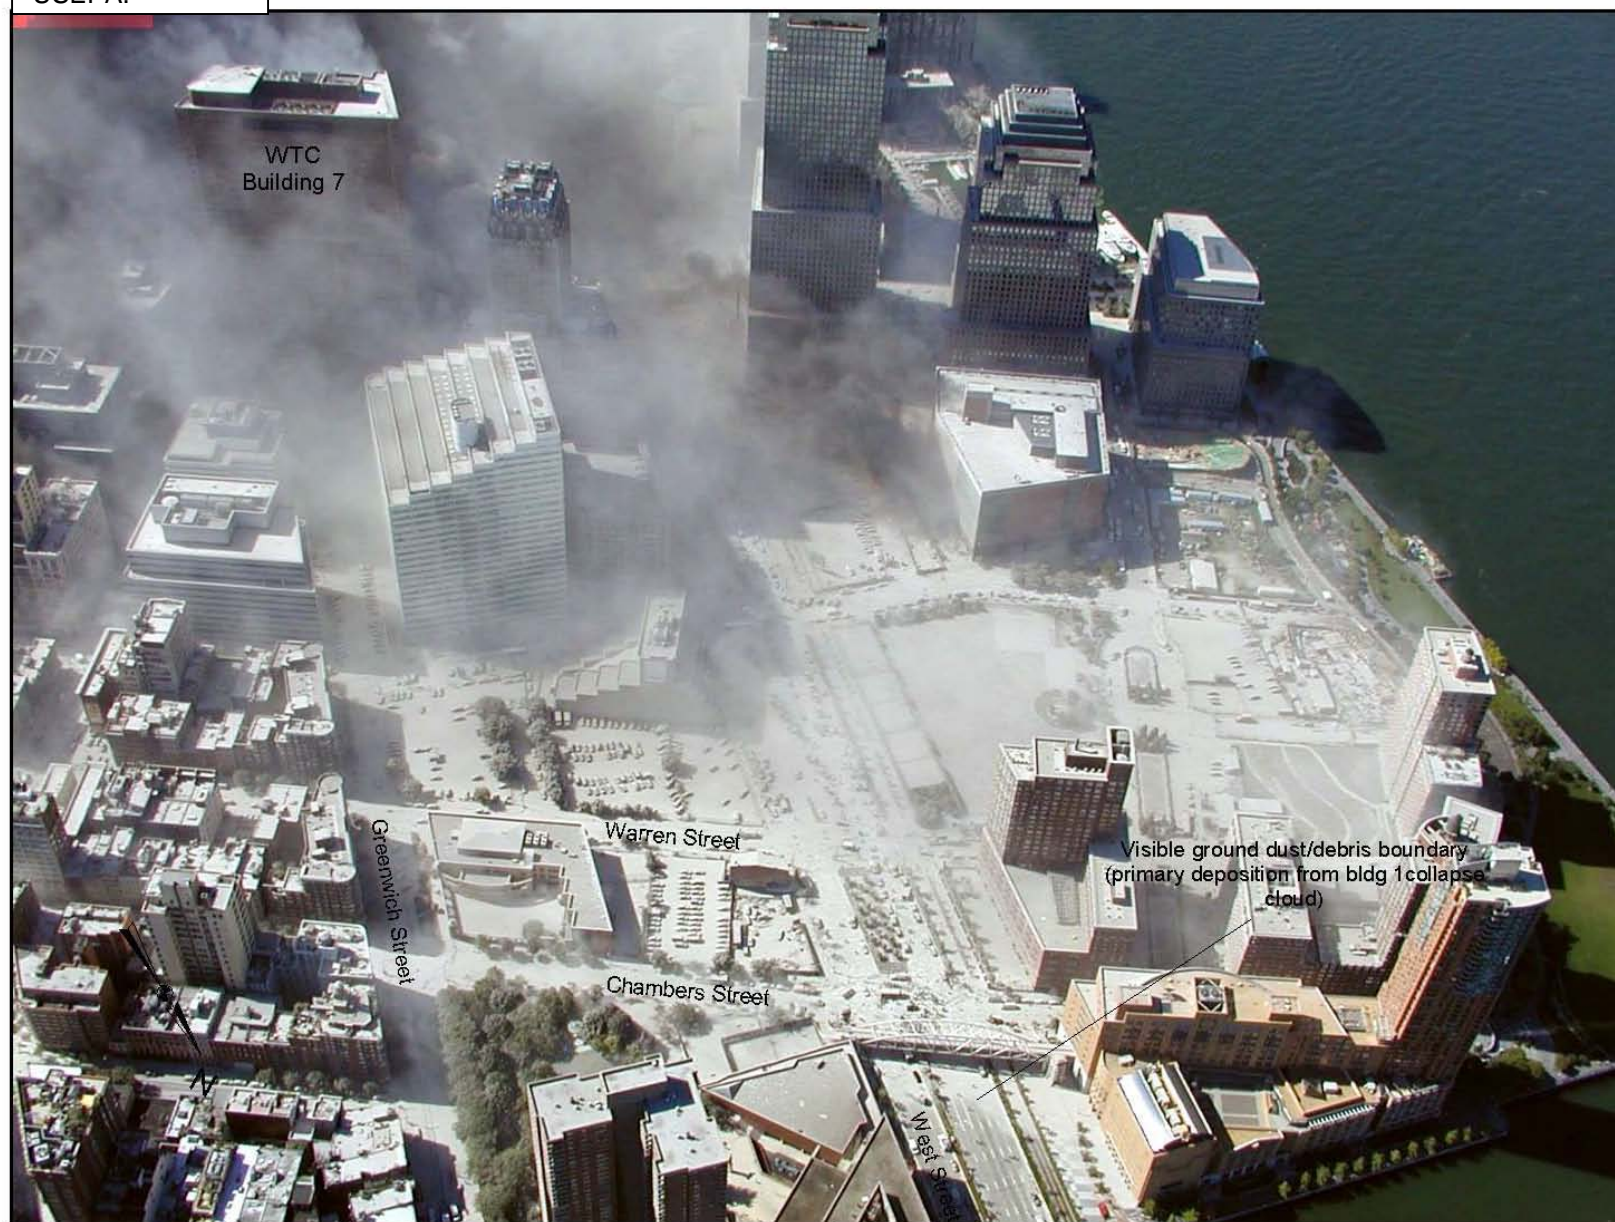
Figure 2E. September 11, 2001. Source: NYPD image 54. Time is between 10:30am and 5:30 pm. The northern extent of the WTC building 1 collapse cloud has begun to recede. WTC building 7 is visible. The visible ground dust/debris boundary, along West Street, is now located at the intersection of West and Chambers Streets.

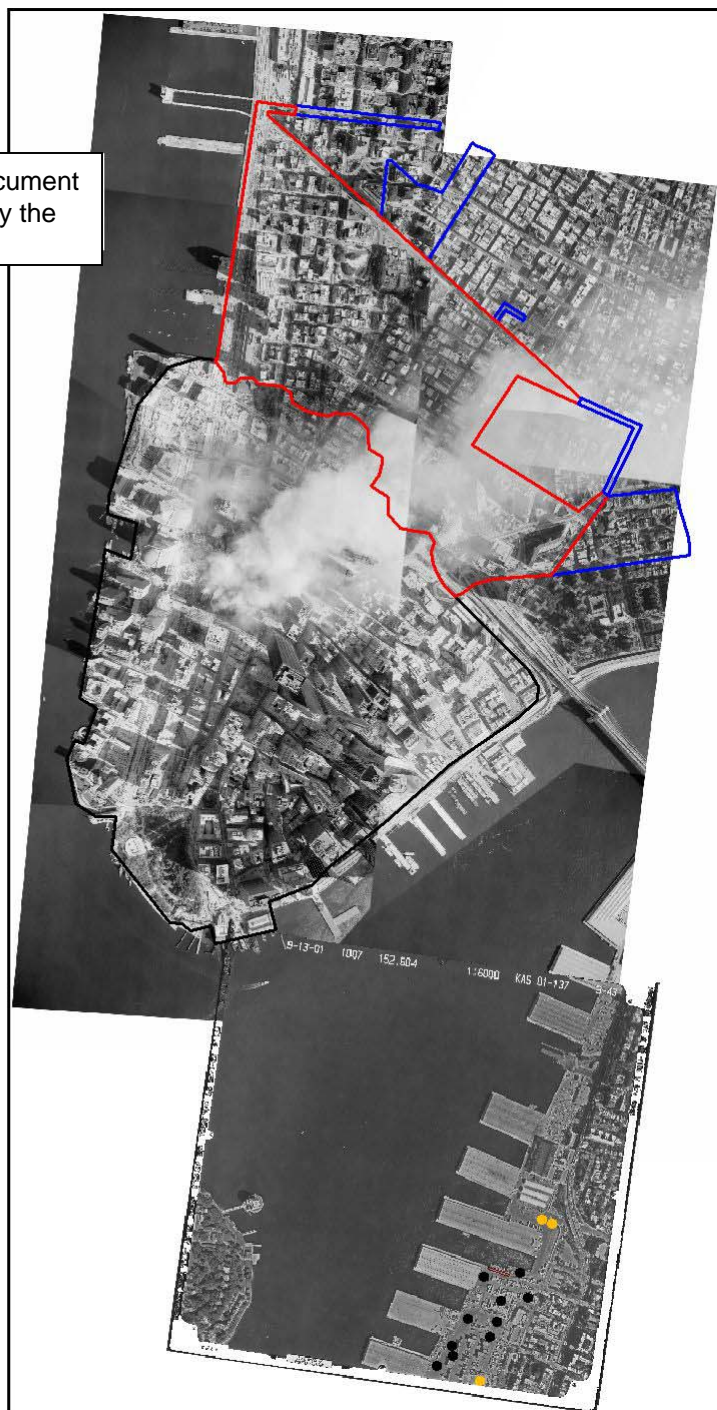
**Mapping Results from September  
13, 2001 aerial photographs**

Figure 12. September 13, 2001. Image mosaic of lower Manhattan and portions of Brooklyn. Points in black represent areas where vehicle tracks and possible dust were observed along wharf areas in Brooklyn.

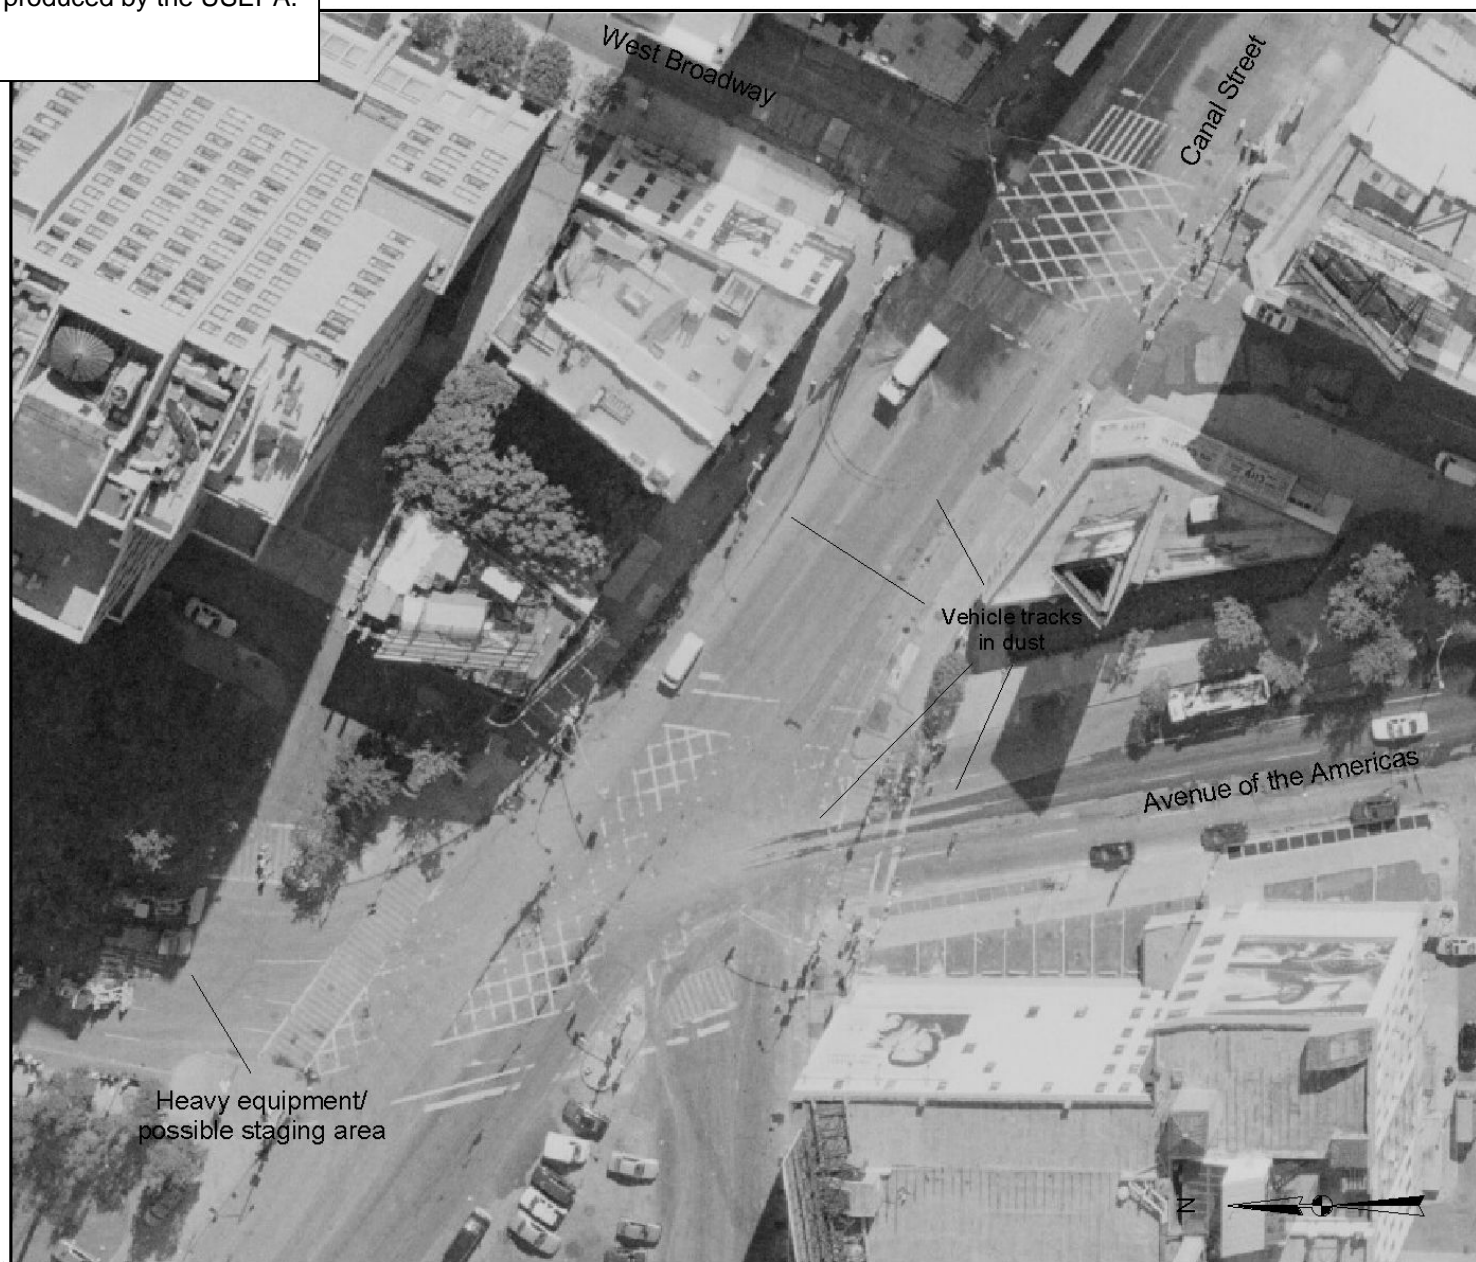
Figure 13. September 13, 2001. Enlarged image providing an example of probable dust along Canal Street between West Broadway and the Avenue of the Americas.

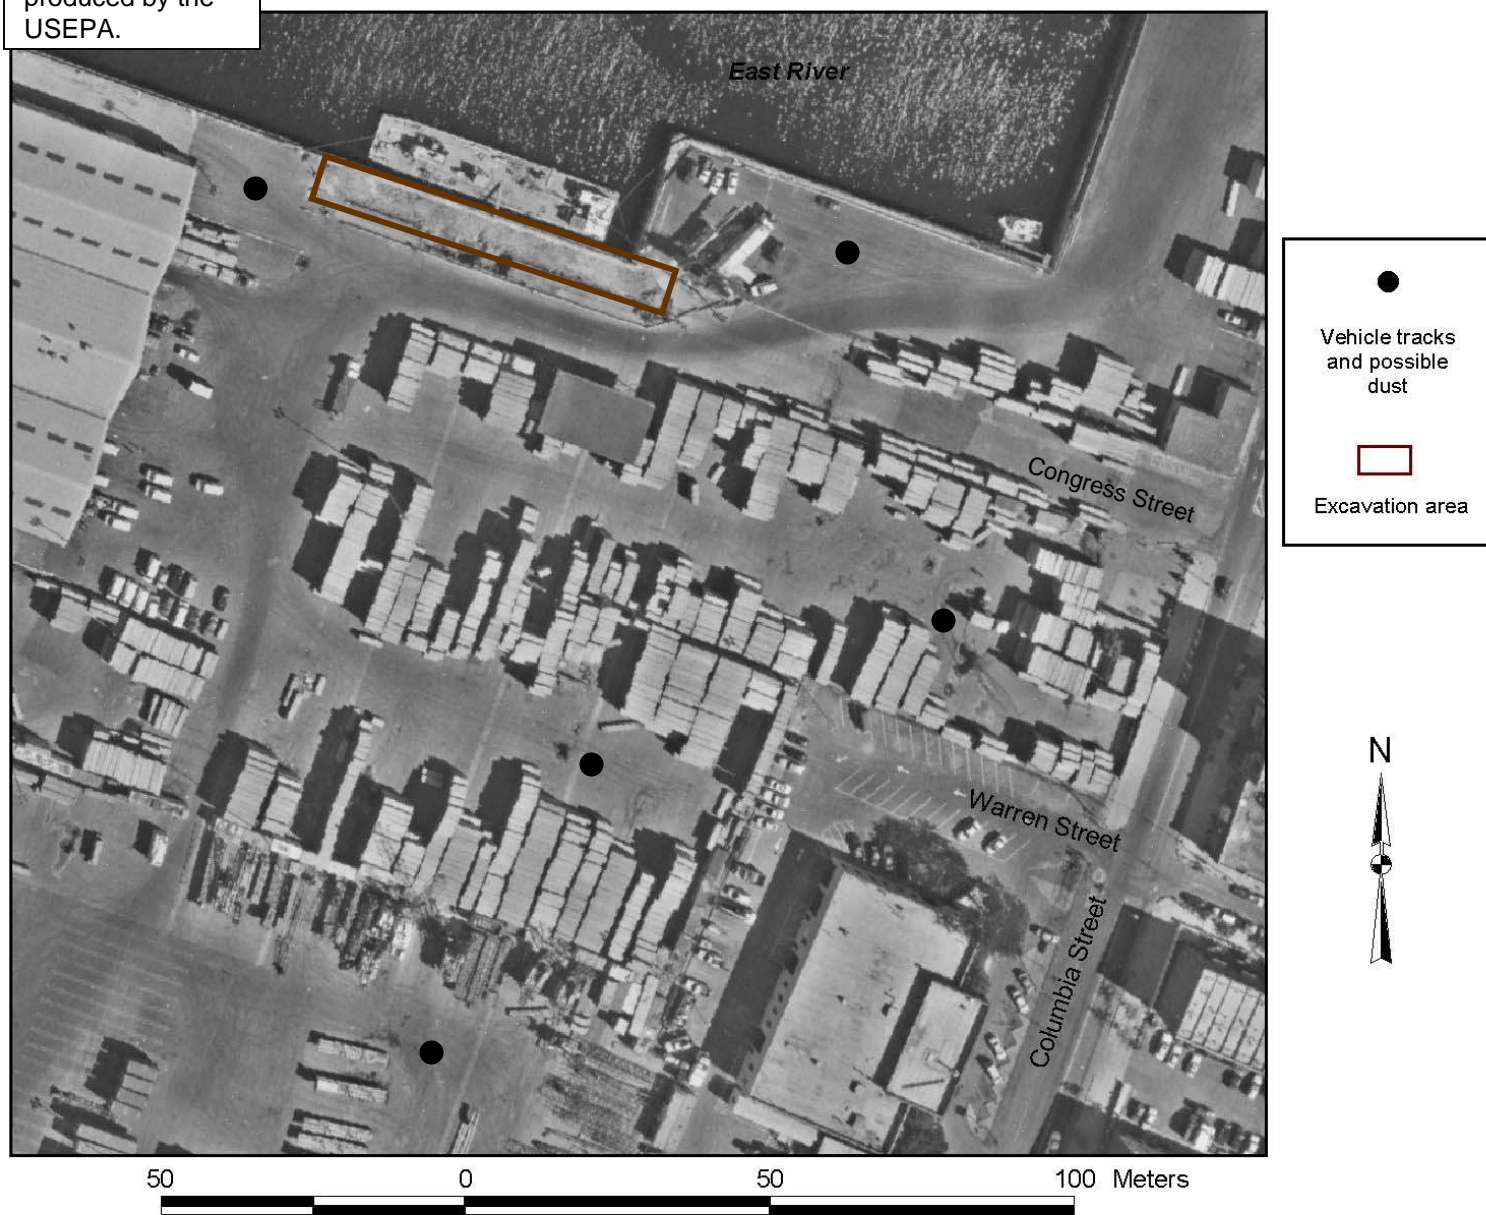
Figure 14. September 13, 2001. Enlargement of wharf area in Brooklyn along the East River in the vicinity of the intersection of Congress and Columbia Streets. Locations of vehicle track patterns, in dust, are noted as black points. The excavation area is mapped in brown.
